TECHNICAL REPORT SL-86-33

# DYNAMIC FAILURE TESTS AND ANALYSIS OF A MODEL CONCRETE DAM

C. Dean Norman

September 1986

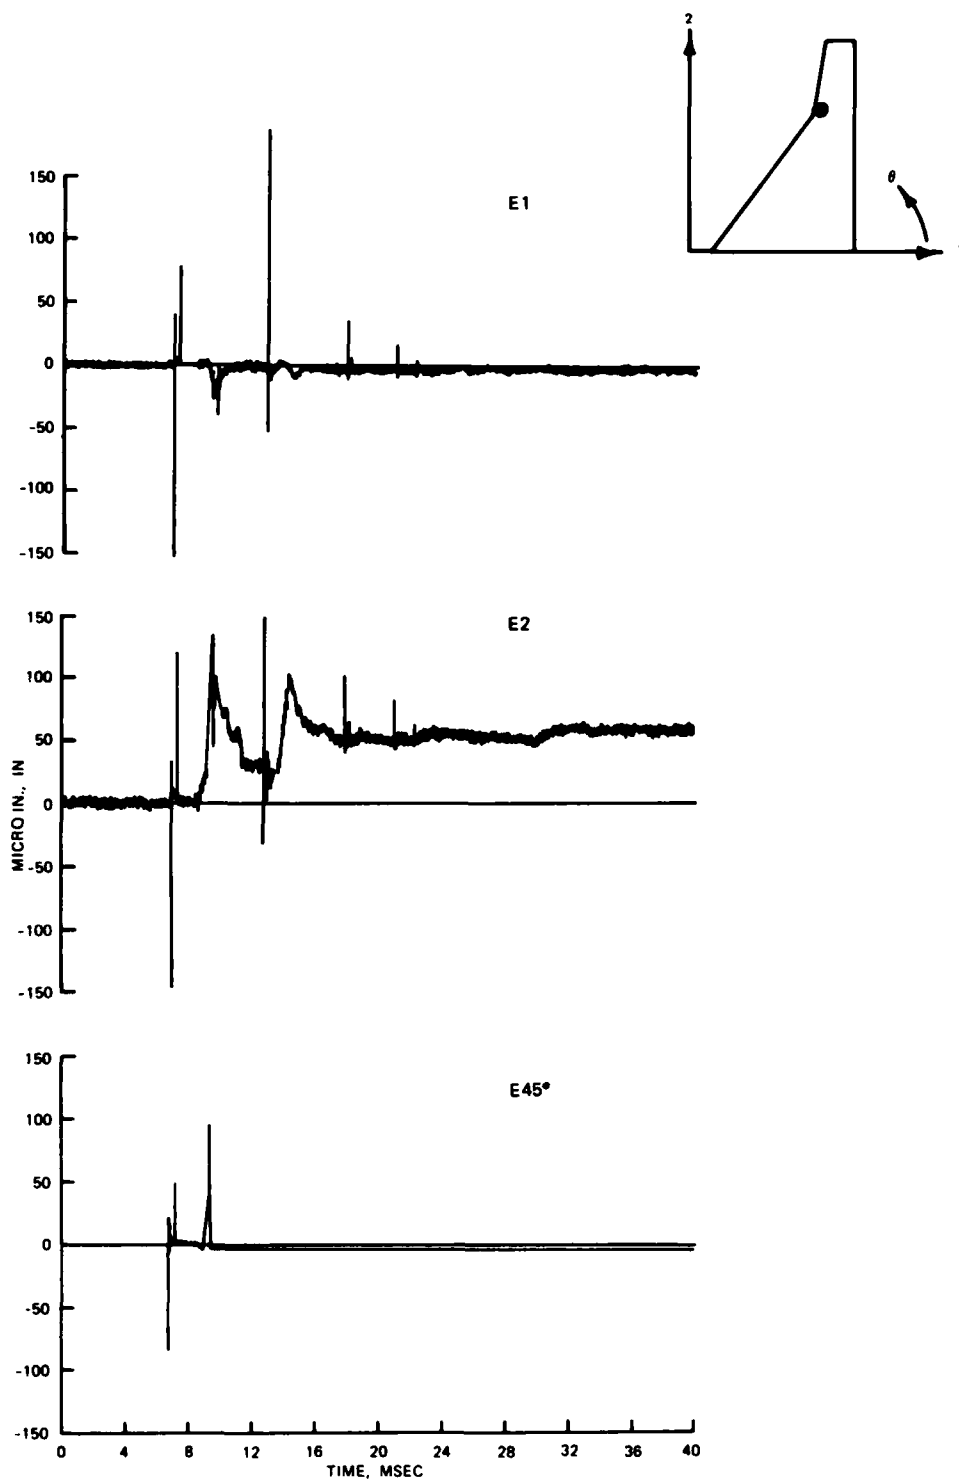
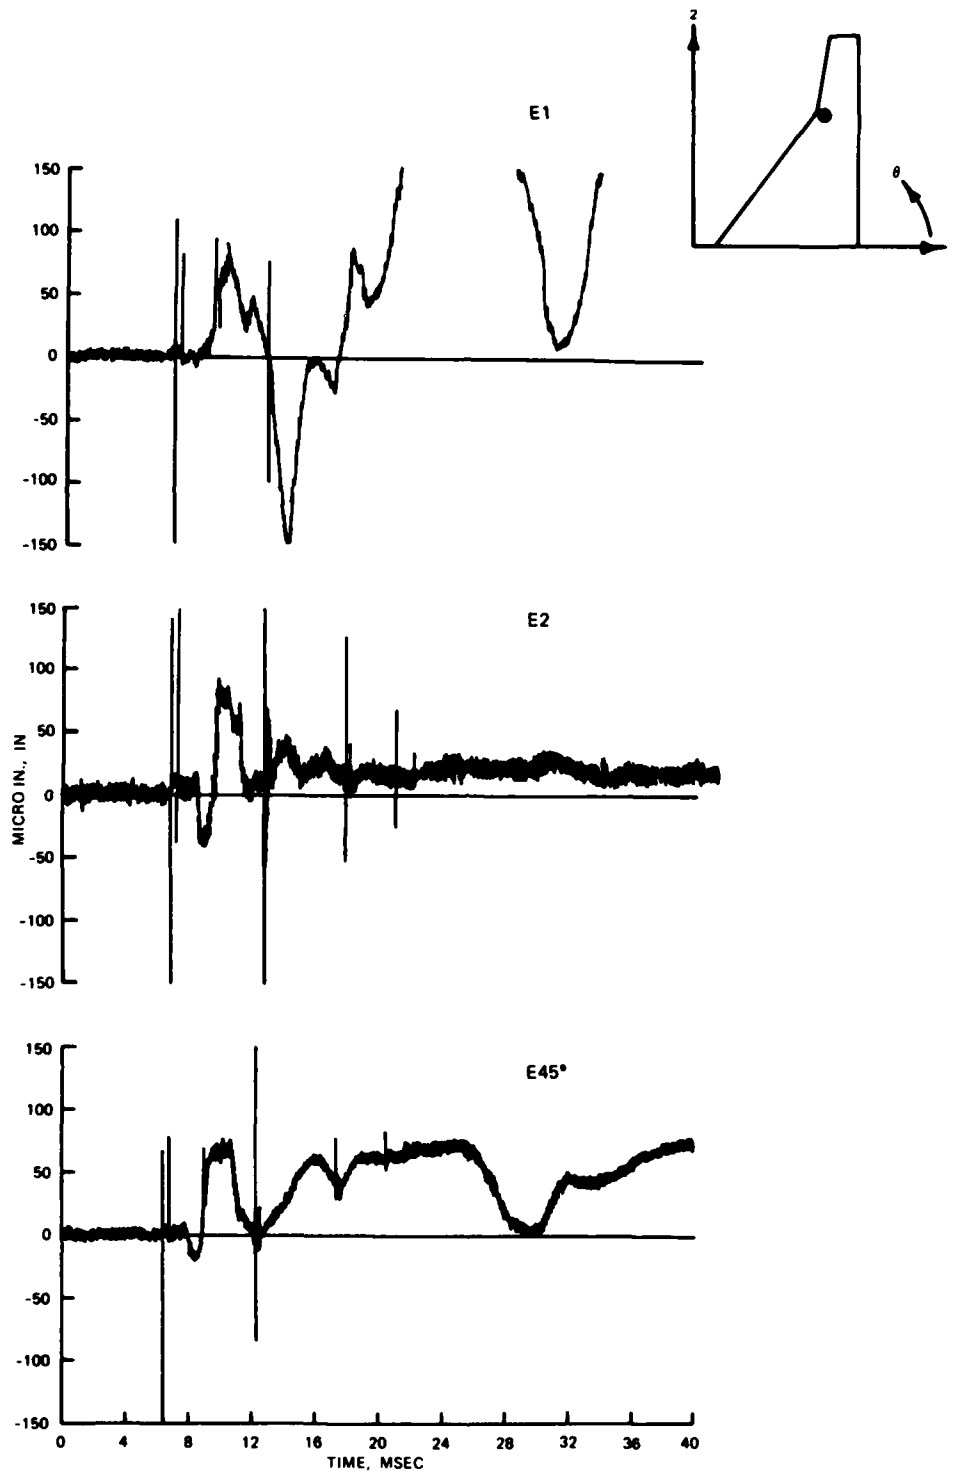
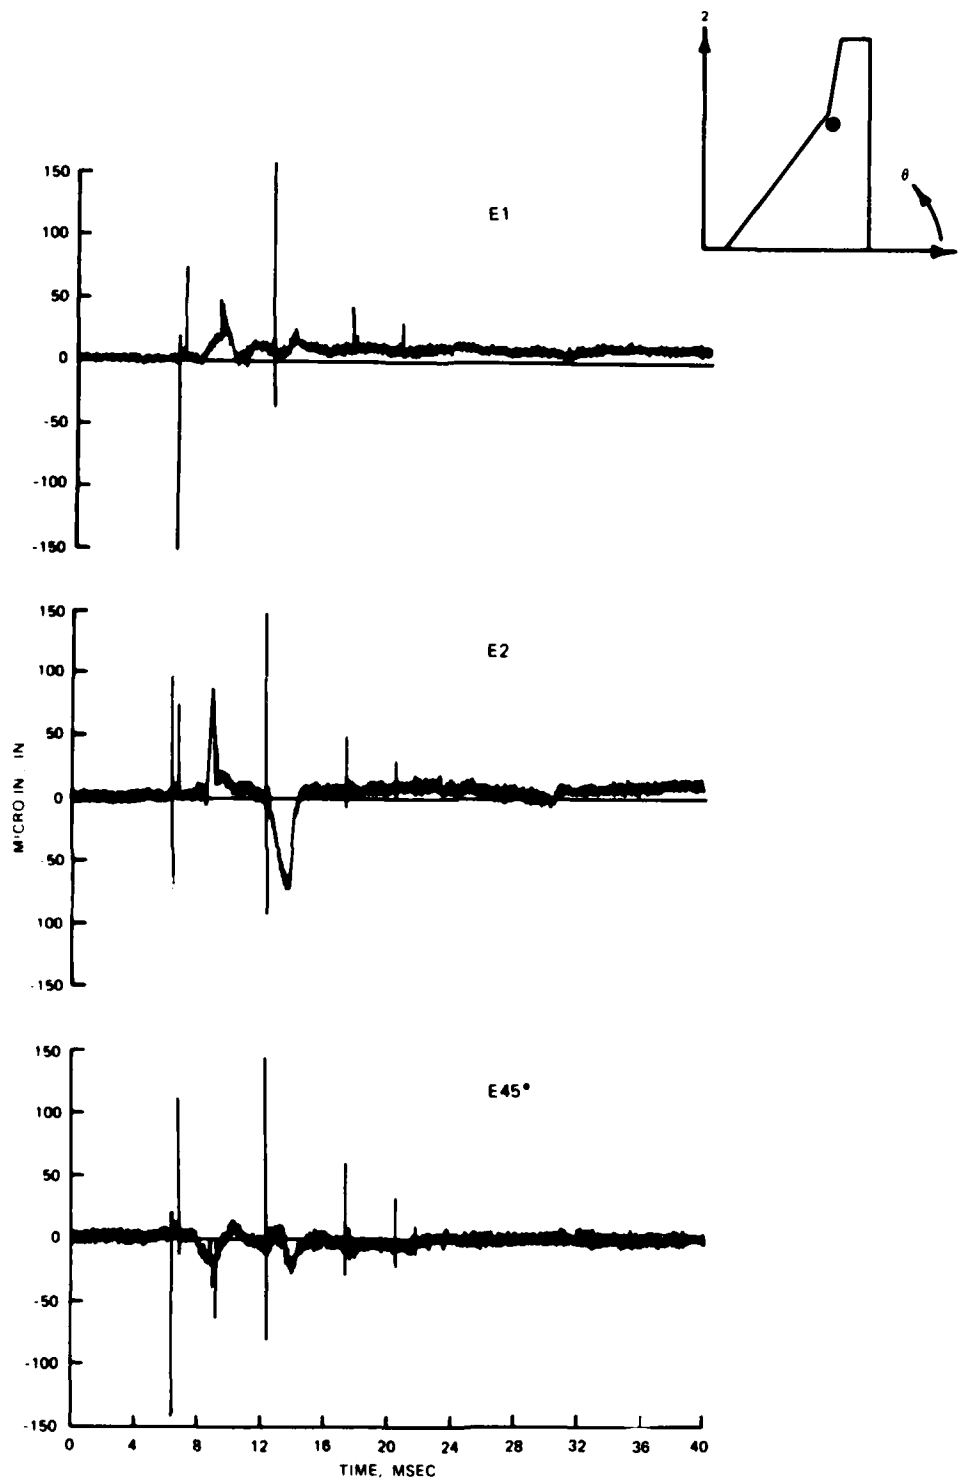
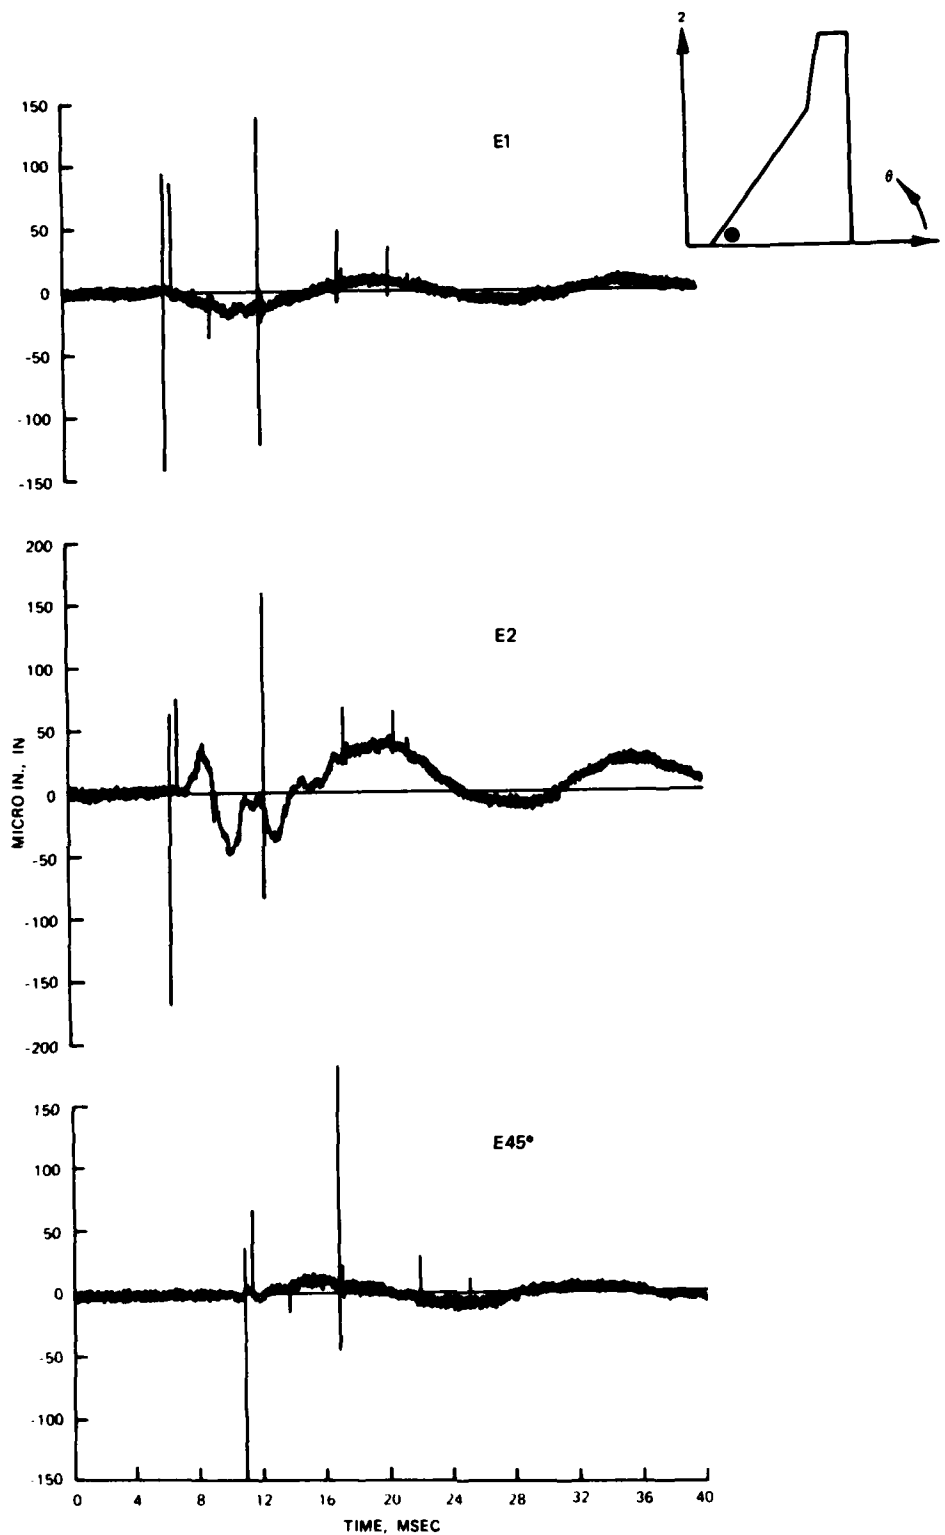
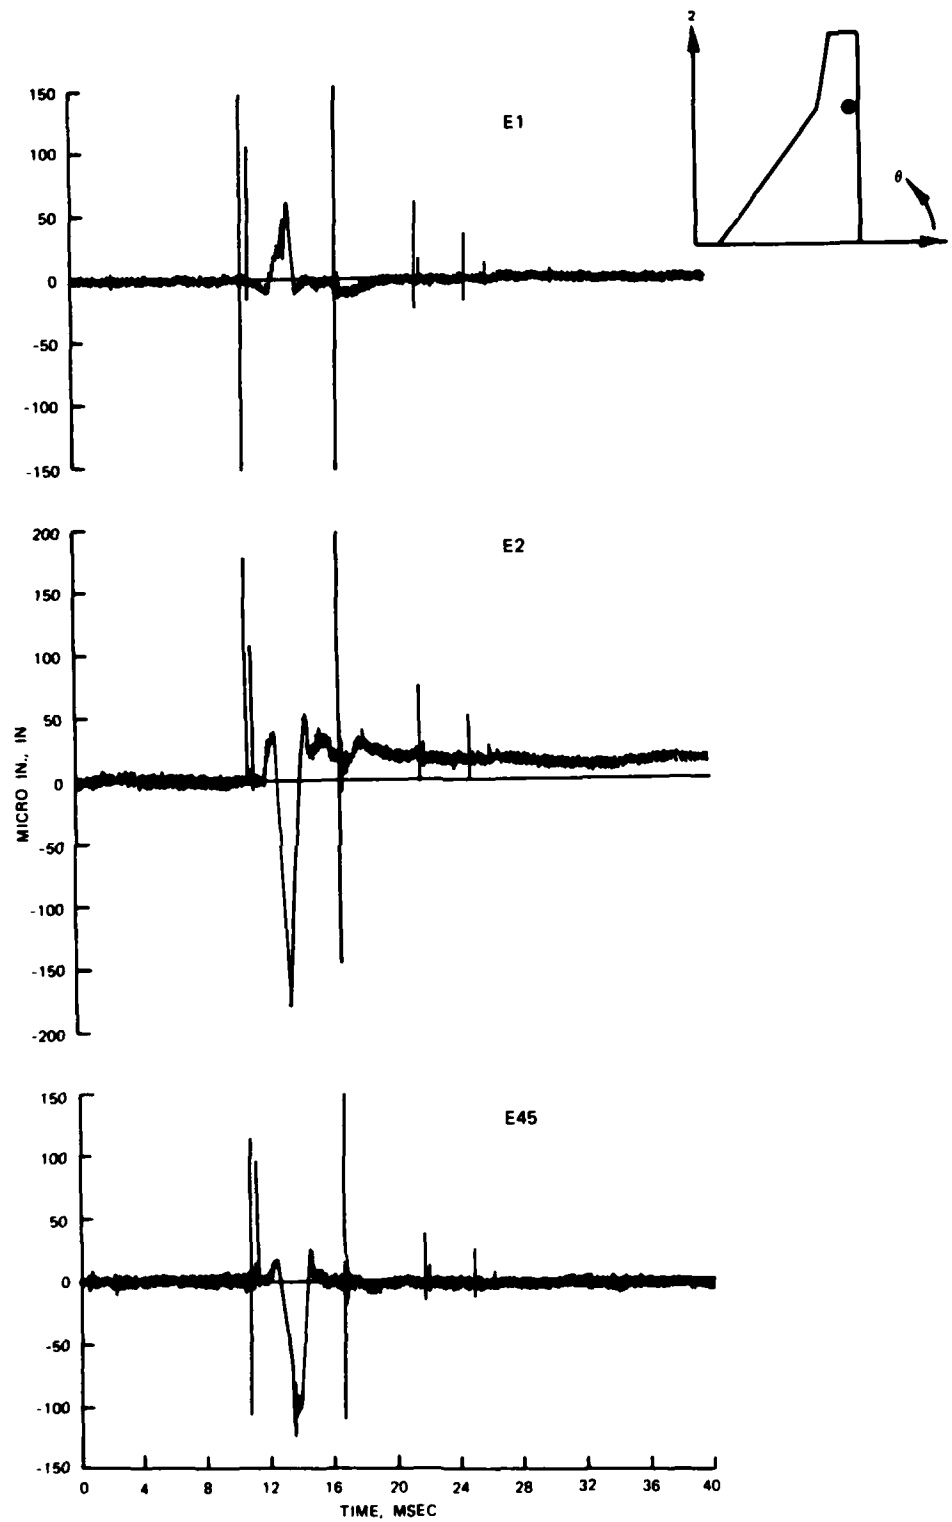
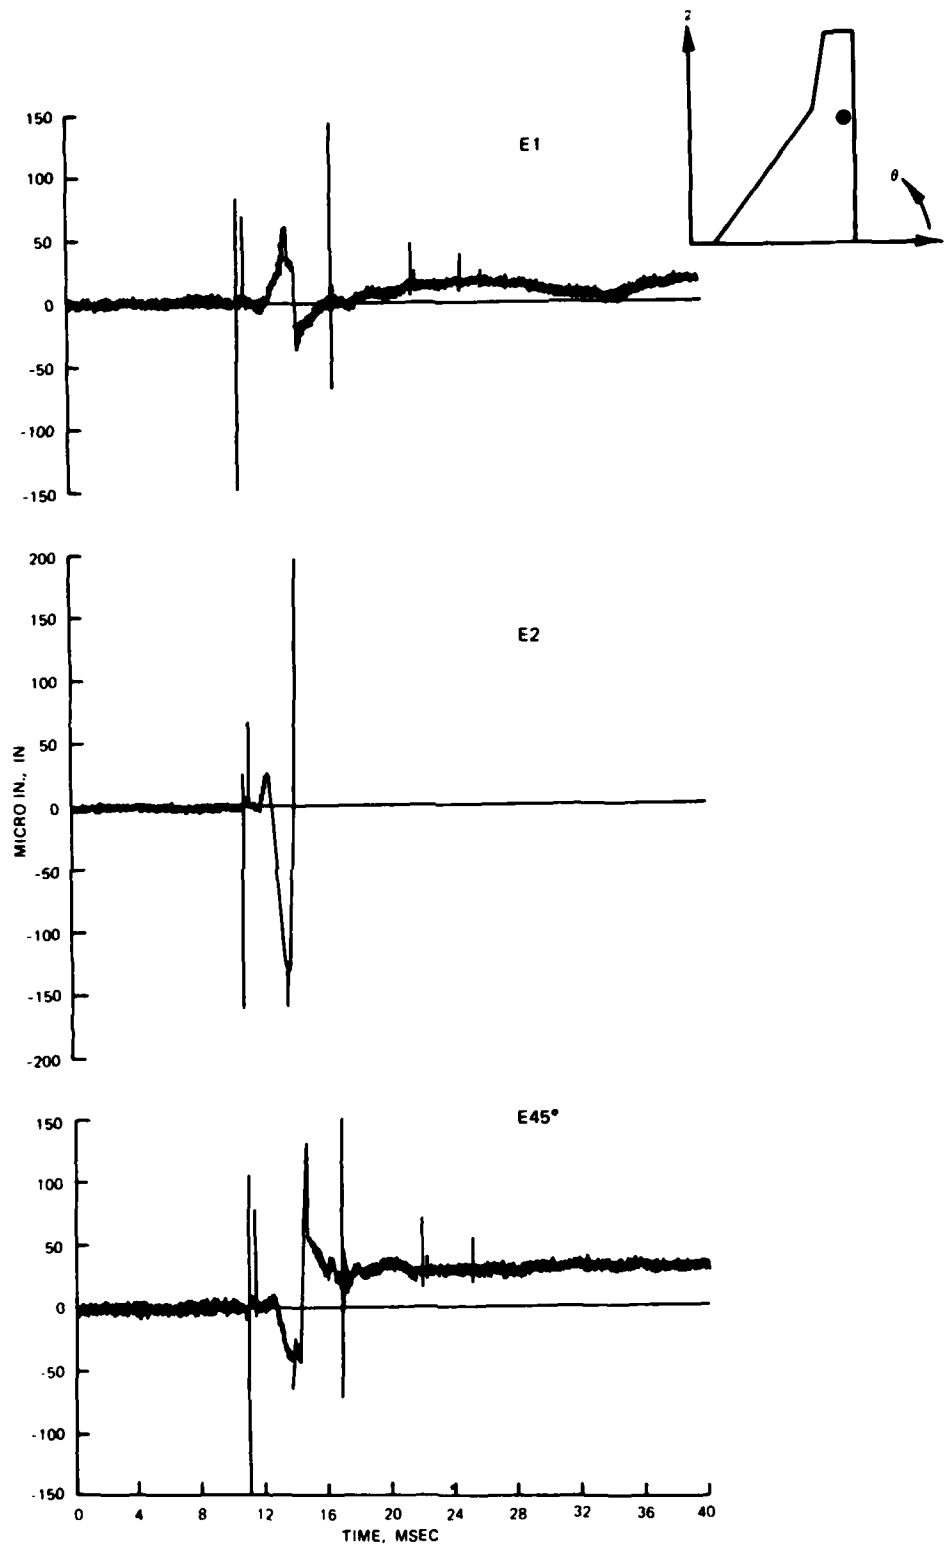
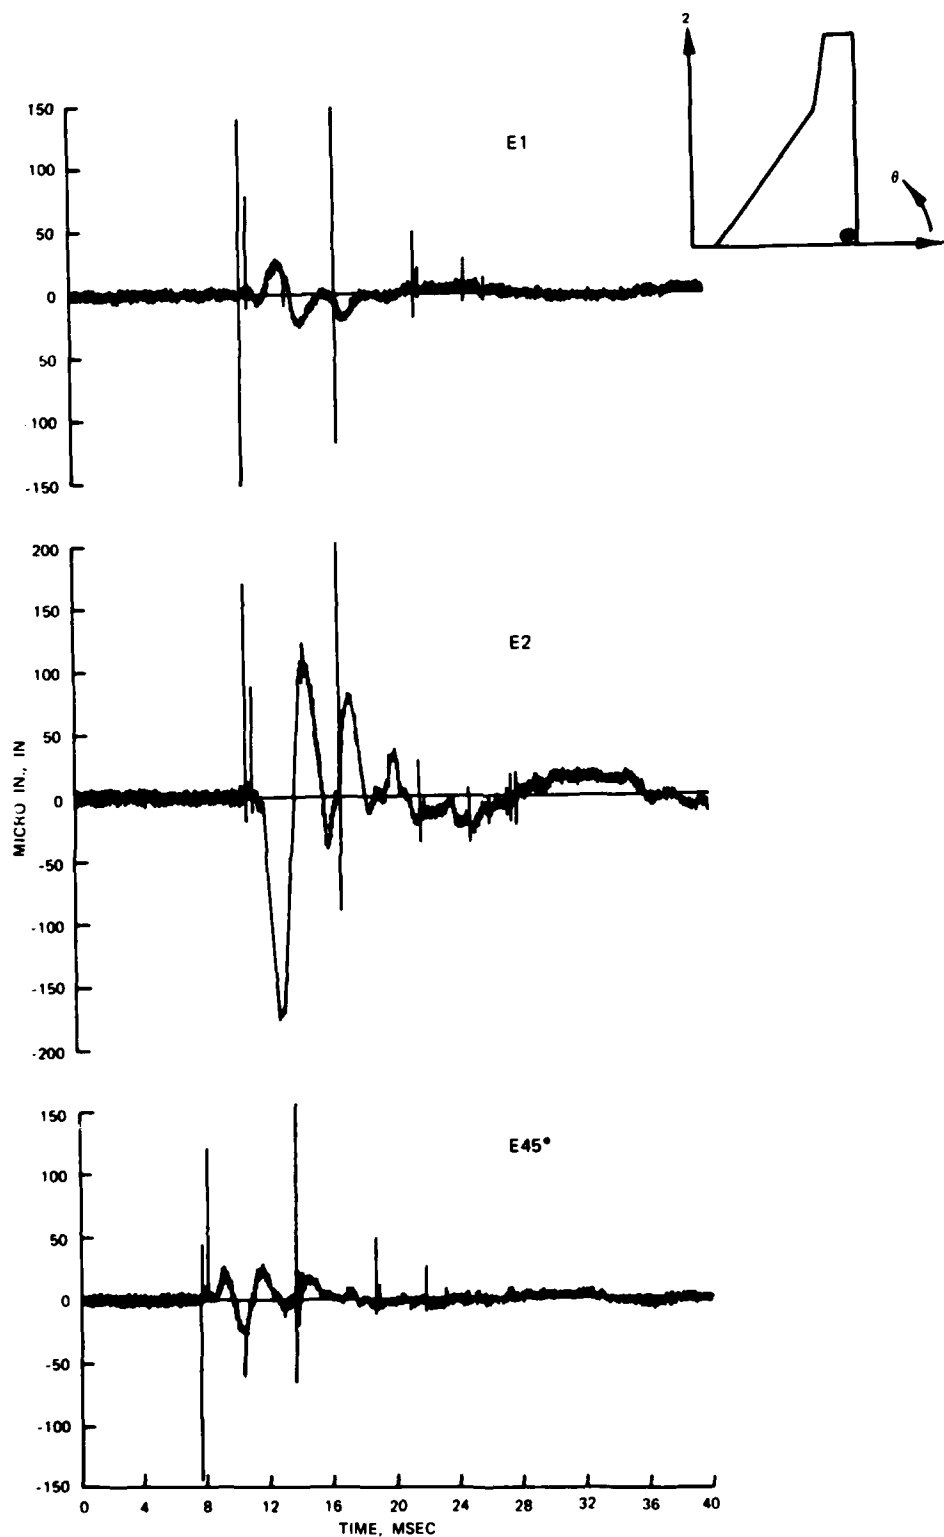
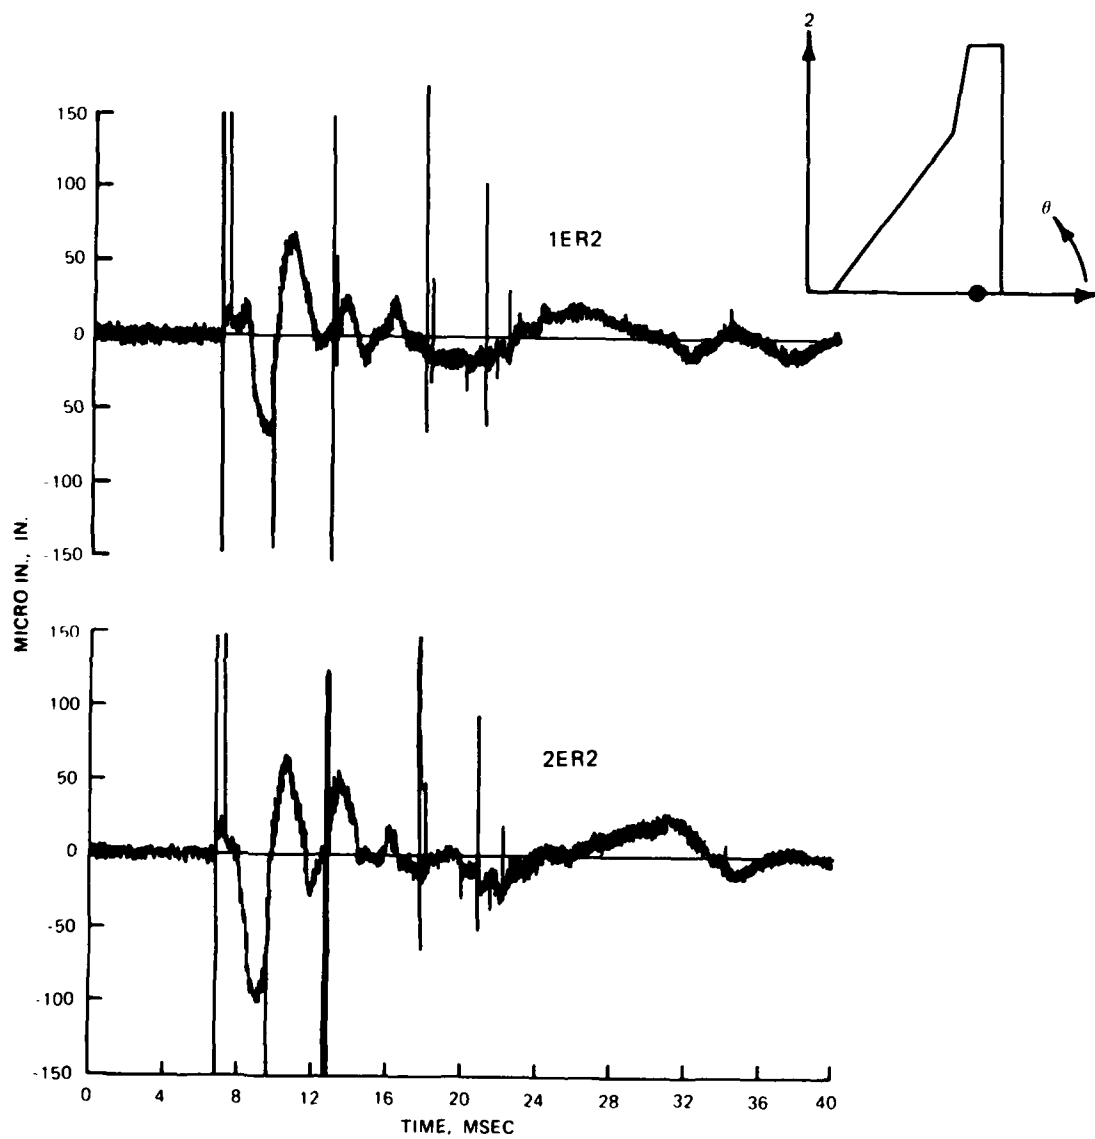
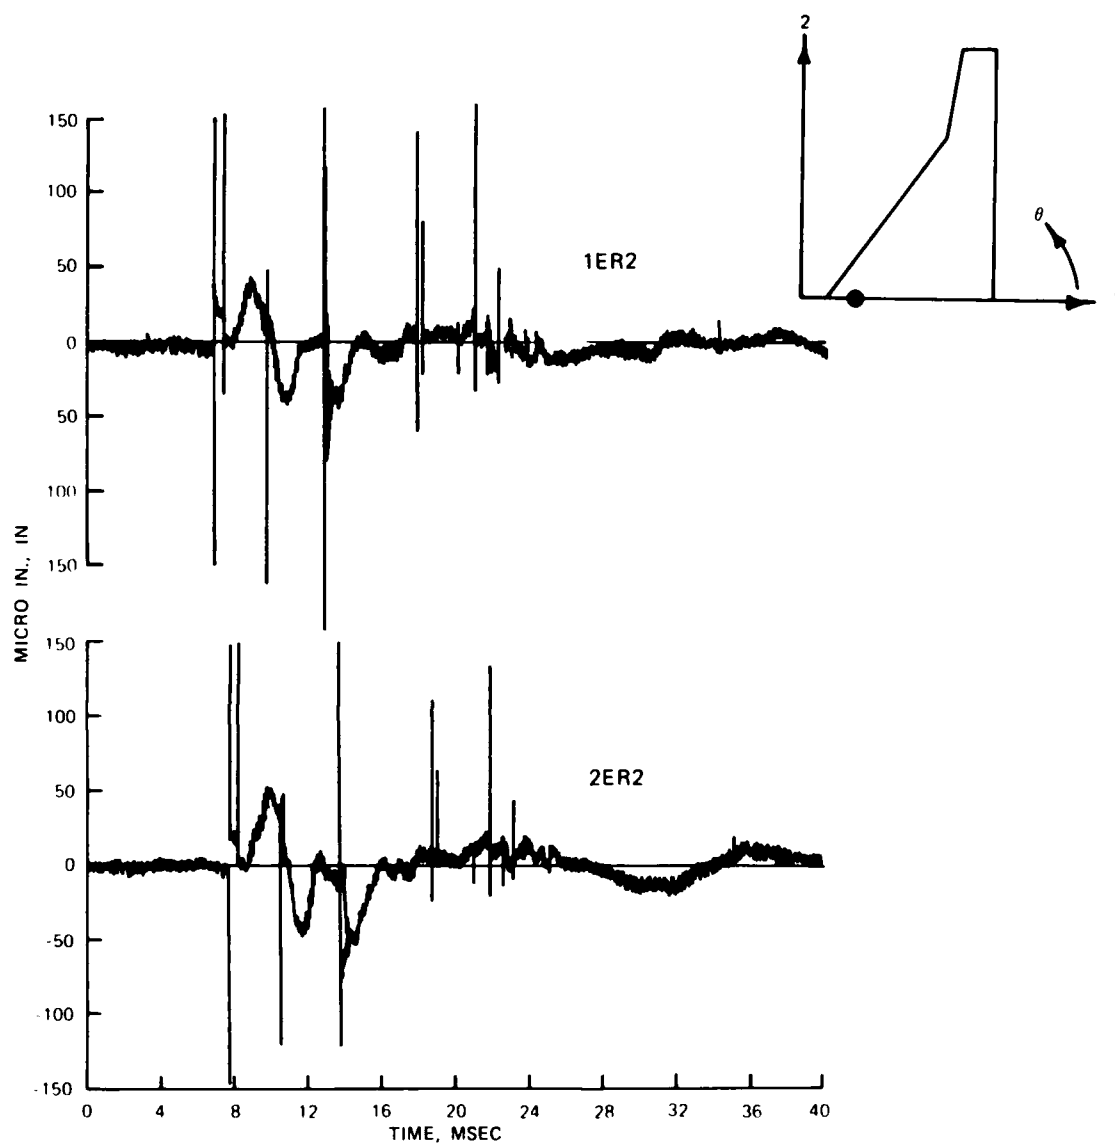
16. Unfiltered strain versus time plots from the embedded strain gages used in the dynamic failure test are presented in Figures 9 through 17. Zero time for each of these plots should be taken at the time when the first relatively large spike occurs on the record. At each point (Figure 7) three strains are recorded and presented in each figure. Also, strains were measured on short No. 2 vertically oriented rebars placed near the heel and toe at the dam-foundation interface. These rebars were placed at the

20. As mentioned earlier, measured strains versus time records are presented in Figures 9 through 17. Also, zero time for each record should be taken as that time when the first spike occurs on that particular record. The crack on the upstream face occurred at an elevation of approximately 39 in., which is very near the elevation of the strain gage whose record is presented in Figure 14. Also, the crack on the downstream face occurred close to gages whose records are presented in Figures 9 and 10. Based on these records, it appears the crack formed somewhere between 2.5 and 3.0 ms after impact. Strain measurements at the base near the heel are presented in Figure 15 and near the toe are presented in Figure 12. The vertical strains oscillate at a frequency of about 250 Hz for 8 to 9 ms, then a slow oscillation at about 60 Hz is observed in Figures 12 and 15. Strains near the heel and toe occurring at the slower frequency are felt to be the results of the dam responding as a rigid body rocking on the foundation which is oscillating due to the Belleville springs near the 60-Hz region.

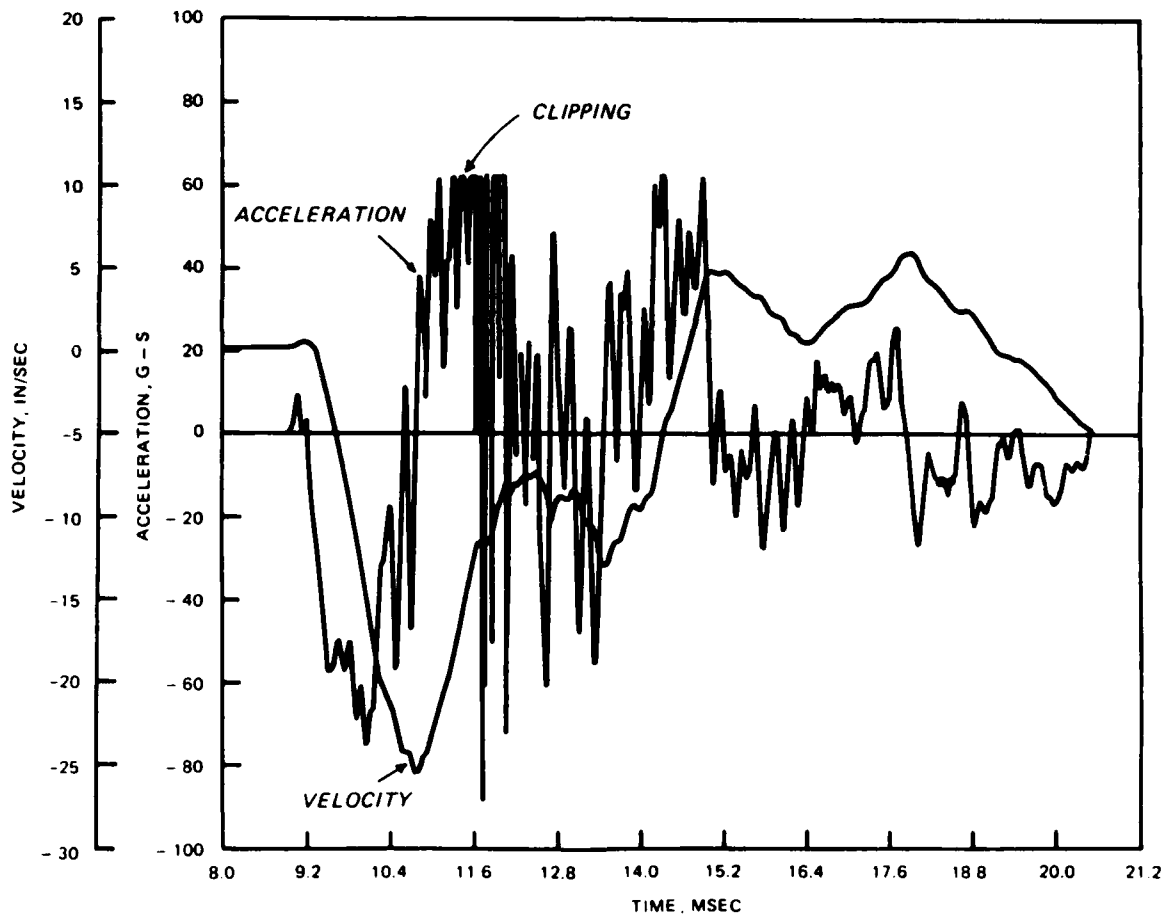
17. As mentioned previously, all of the accelerometers were clipped in the failure test. However, the accelerometer at approximately 39 in. above the top of the foundation block (Figure 1) appeared to record reasonable accelerations up to the time of maximum velocity. This can be seen in Figure 18. In this figure obvious clipping of the record occurred at about 11 ms. The peak velocity of approximately 25 in. per sec is close to that predicted by impact calculations made in Part V of this report.

Figure 18. Acceleration and velocity versus time, measured on the upstream face, at approximately thirty nine inches above the foundation block

19. As mentioned earlier, the accelerometer at the model foundation level was to be used to define the input base motion for analysis and evaluation of structural response. However, since all accelerometers were ranged too low, gage signals saturated or clipped as shown in Figure 18. However, the gage represented by Figure 18 (at an elevation of 39 in. above the foundation) can be used as an indication of the initial acceleration and velocity of the dam foundation system. The initial peak in velocity occurs prior to the major clipping of the gage and is approximately  $v_1 = 25$  in./sec. If the dam is considered to be stiff, then the accelerations at about midheight can be assumed to be about equal to those at the foundation. The input motion at the foundation might then be characterized as a velocity pulse with an amplitude of 25 in./sec and a rise time similar to the early time portion of the signal
